# Problem Solving

High levels of downtime and low OPR on an Engine Installation process in an automotive Assembly Shop, comprising a bottleneck affecting the throughput of the whole Shop.

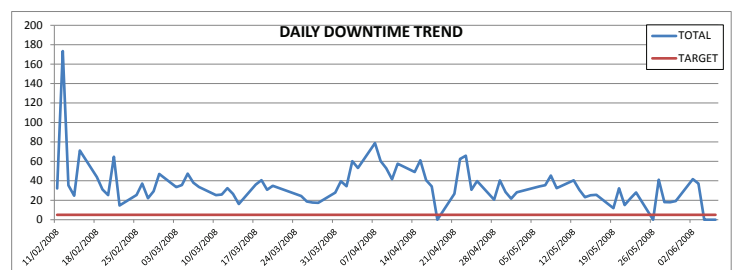
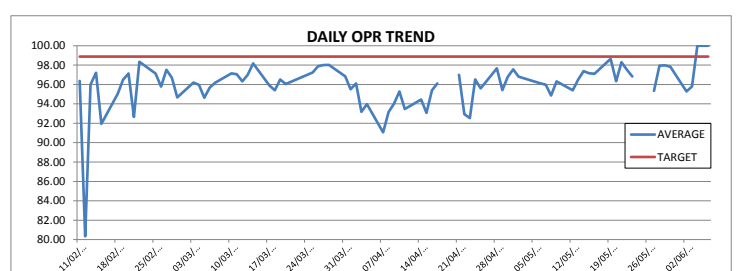
Daily track of downtime and OPR on both shifts:

- Downtime: avg 67 to 15 mins per week = 78% reduction
- OPR: avg 92.3 to 98.2% = 6% improvement

First Time Correct:

- 1st Time Correct: 50% Improvement
- All severe and critical issues eliminated
